Inspection Report Title Page

222 Moving Soon Lane

Inspection Date: 08 / 04 / 2008

SAMPLE

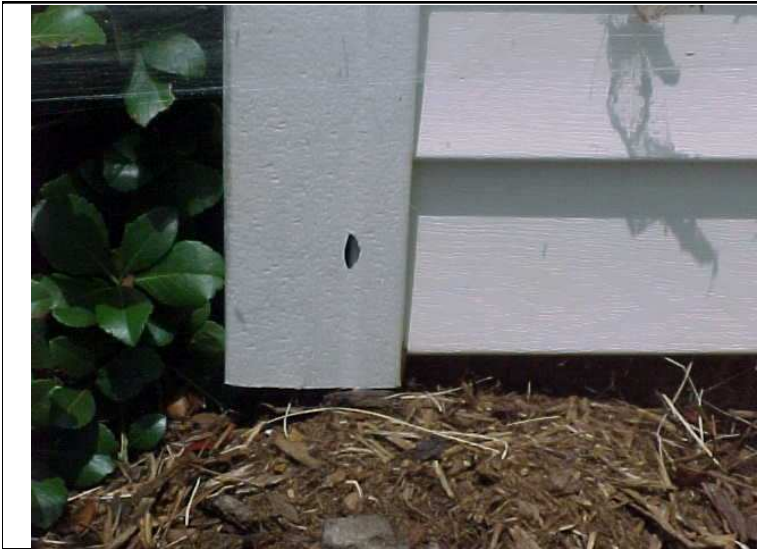
Repair/replace various areas of minor impact damaged vinyl siding, corner trim, etc. around several areas of home, consult vinyl siding contractor.

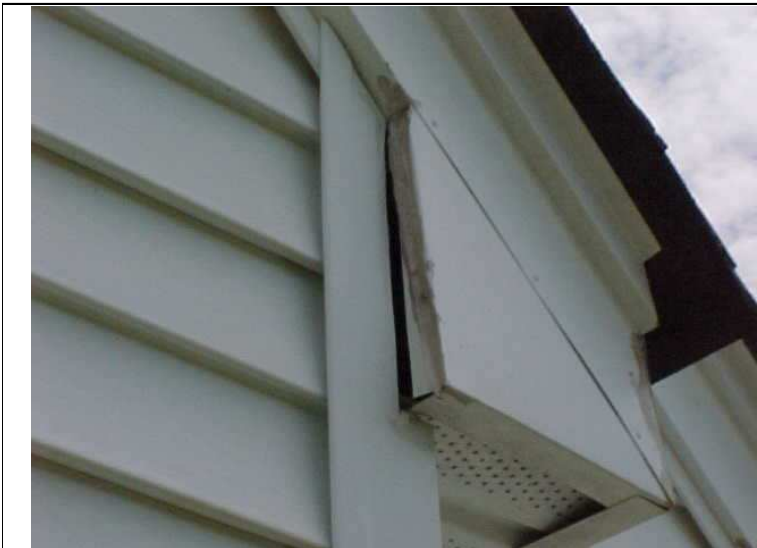
Secure loose fascia/soffit covering at eave(cornice) at right front corner of home.

Soffit, Fascia and Eaves **Aluminum Soffit/Fascia** S
 NP
 NI
 NR
 Fascia is covered with boxing and gutters and could not be fully inspected. Soffit is covered with aluminum/vinyl and could not be fully inspected. Secure loose fascia/soffit covering at eave(cornice) at right front corner of home, see picture.

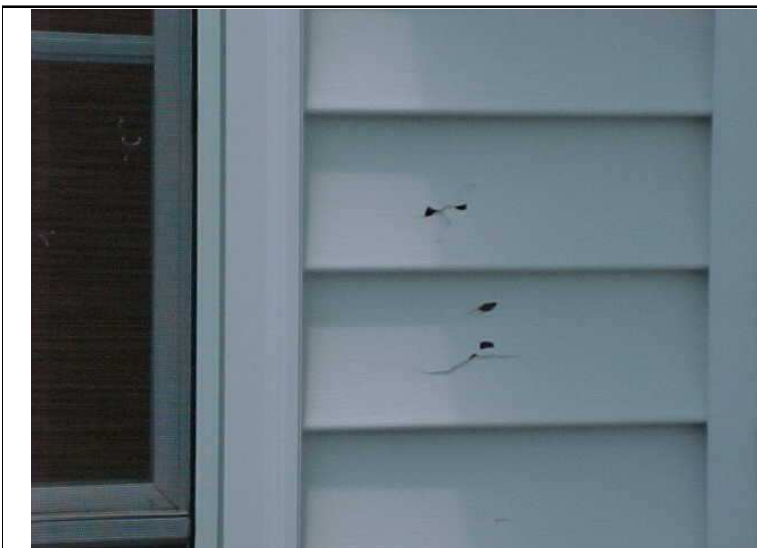
Repair/replace various areas of minor impact damaged vinyl siding, corner trim, etc. around several areas of home, consult vinyl siding contractor.

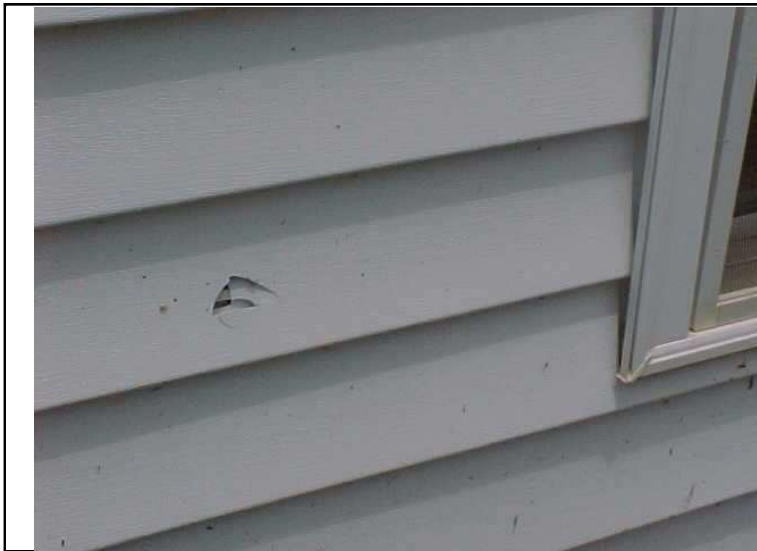
Repair/replace various areas of minor impact damaged vinyl siding, corner trim, etc. around several areas of home, consult vinyl siding contractor.

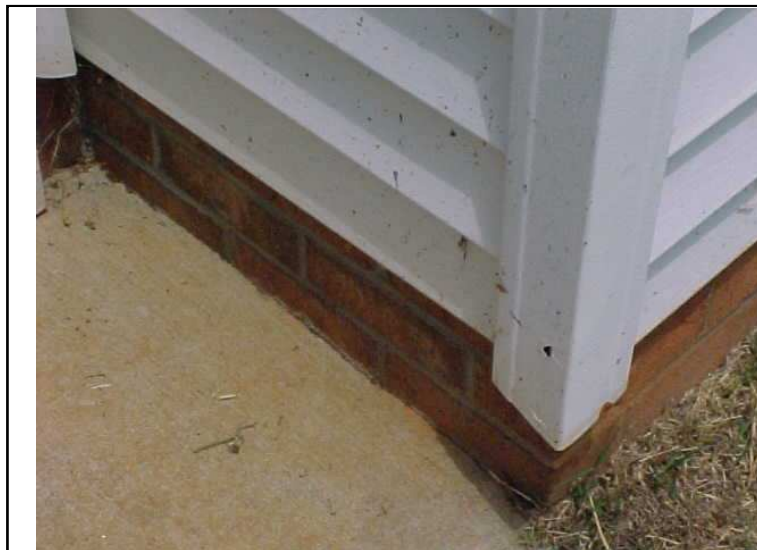
Repair/replace various areas of minor impact damaged vinyl siding, corner trim, etc. around several areas of home, consult vinyl siding contractor.

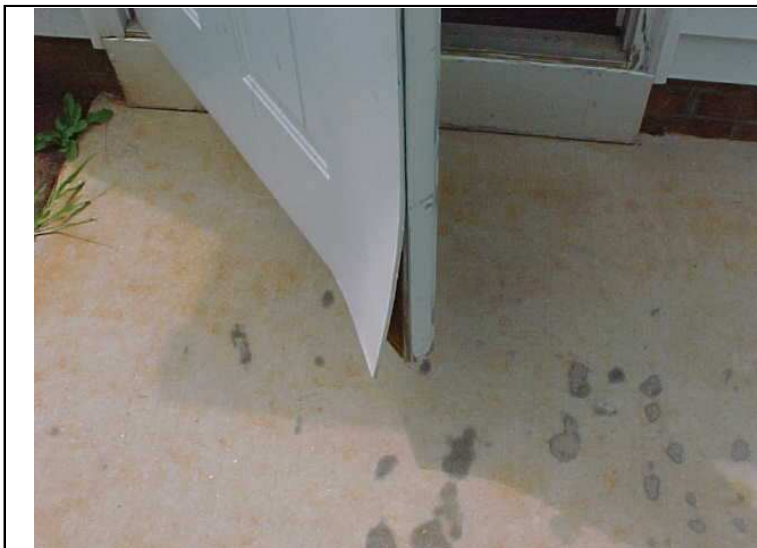
Repair/replace damaged exterior door to exterior storage room.

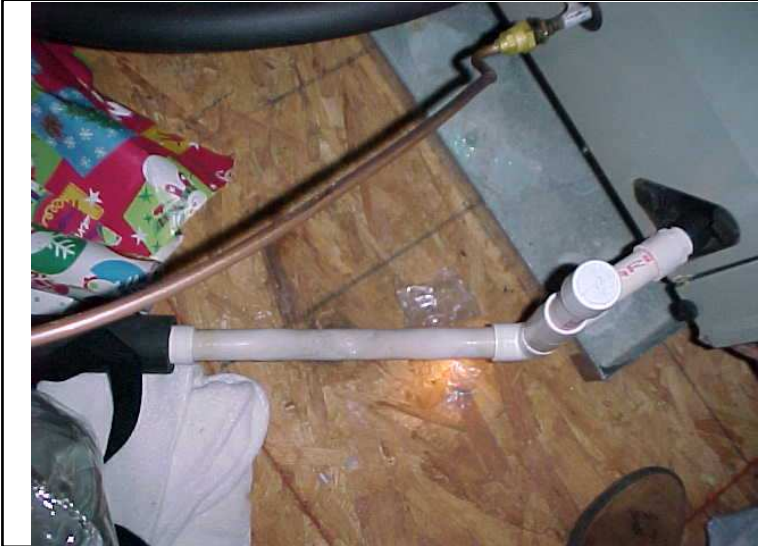
Replace missing portion of armoflex insulation on condensation drain line from unit in attic, consult HVAC technician.

Heating function(s) of heat pump serving home not tested due to manufacturer's recommendation not to test during high outdoor temperatures. Replace missing portion of armoflex insulation on condensation drain line from unit in attic, see picture, consult HVAC technician.

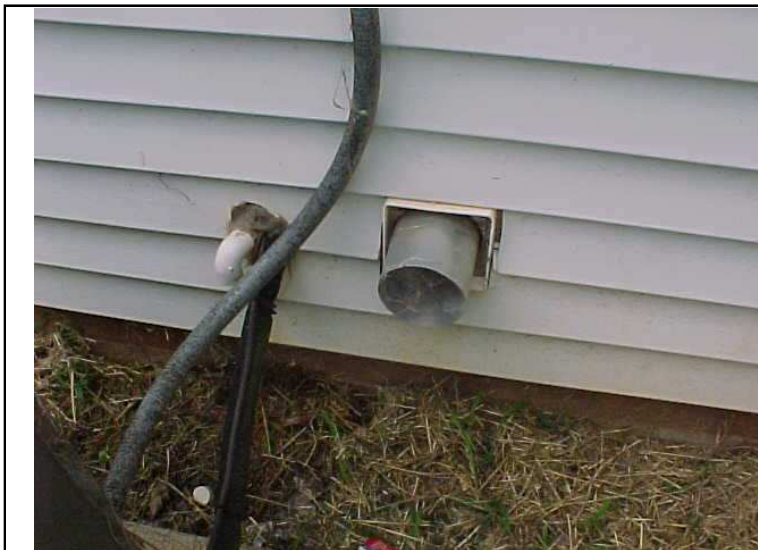
Replace the rain cap that is missing where the dryer exhausts to the exterior.

Laundry Connection/Dryer Exhaust Washer, Electric Dryer, Dryer vented outside
Washer & dryer not present. Connections observed only. Replace the rain cap that is missing where the dryer exhausts to the exterior, see picture.
