Inspection Report Title Page

222 Moving Soon Lane

Inspection Date: 08 / 04 / 2008

SAMPLE

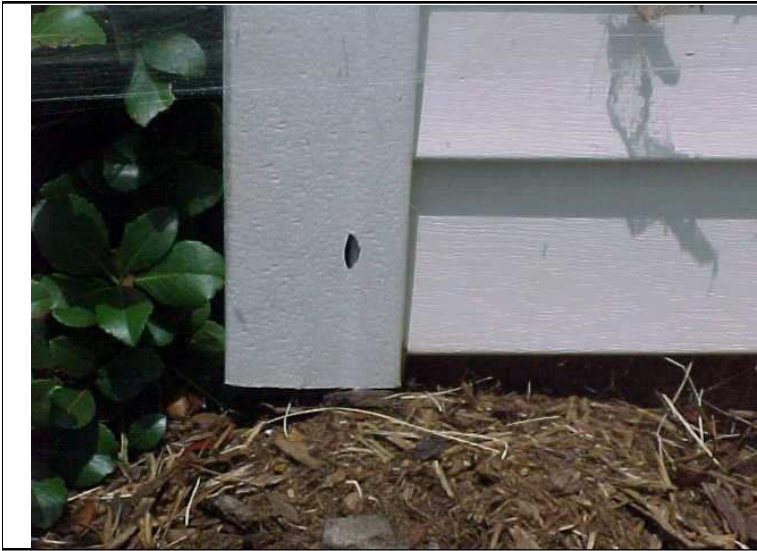
Repair/replace various areas of minor impact damaged vinyl siding, corner trim, etc. around several areas of home, consult vinyl siding contractor.

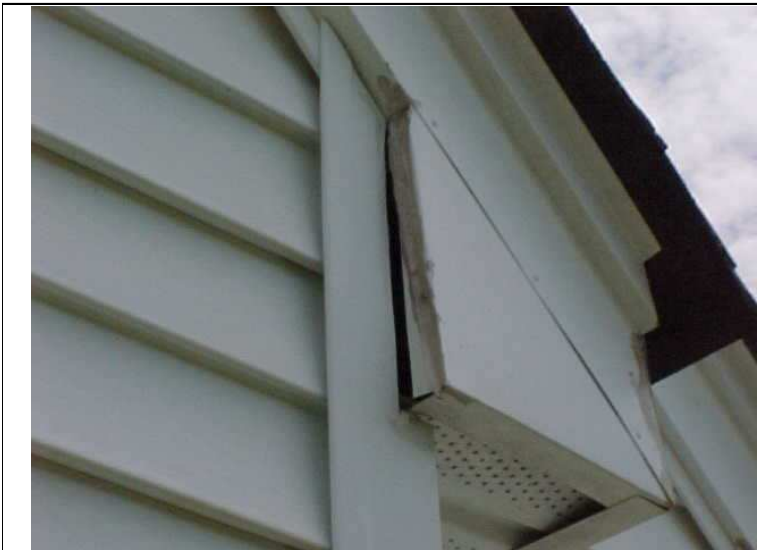
Secure loose fascia/soffit covering at eave(cornice) at right front corner of home.

Fascia is covered with boxing and gutters and could not be fully inspected. Soffit is covered with aluminum/vinyl and could not be fully inspected. Secure loose fascia/soffit covering at eave(cornice) at right front corner of home, see picture.

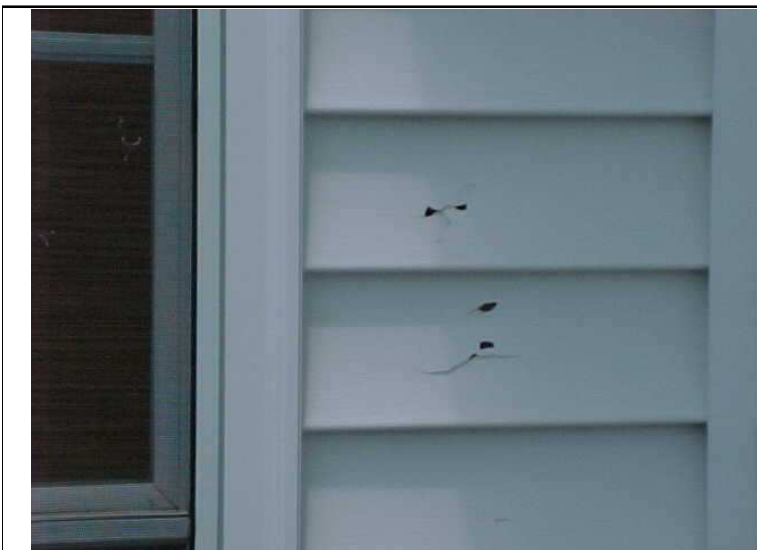
Repair/replace various areas of minor impact damaged vinyl siding, corner trim, etc. around several areas of home, consult vinyl siding contractor.

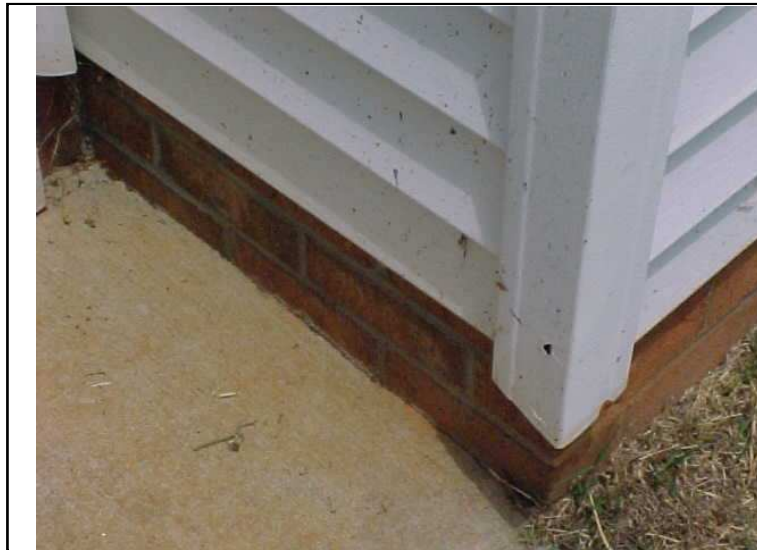
Repair/replace various areas of minor impact damaged vinyl siding, corner trim, etc. around several areas of home, consult vinyl siding contractor.

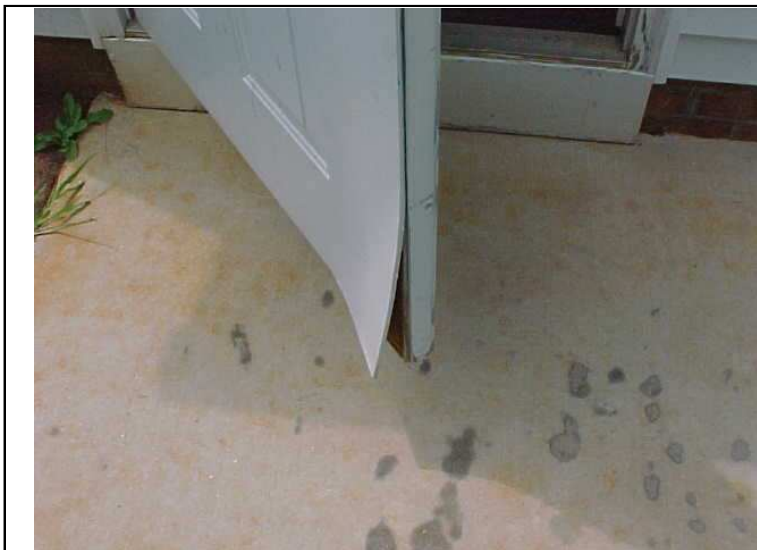
Repair/replace damaged exterior door to exterior storage room.

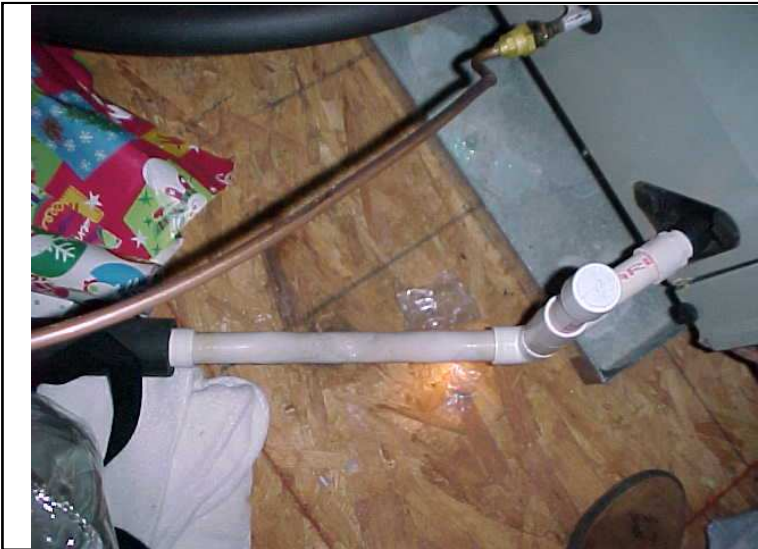
Replace missing portion of armoflex insulation on condensation drain line from unit in attic, consult HVAC technician.
